Fort Worden Pier and Marine Center Facility Condition Assessment Report

Port Townsend, WA

December 21, 2016

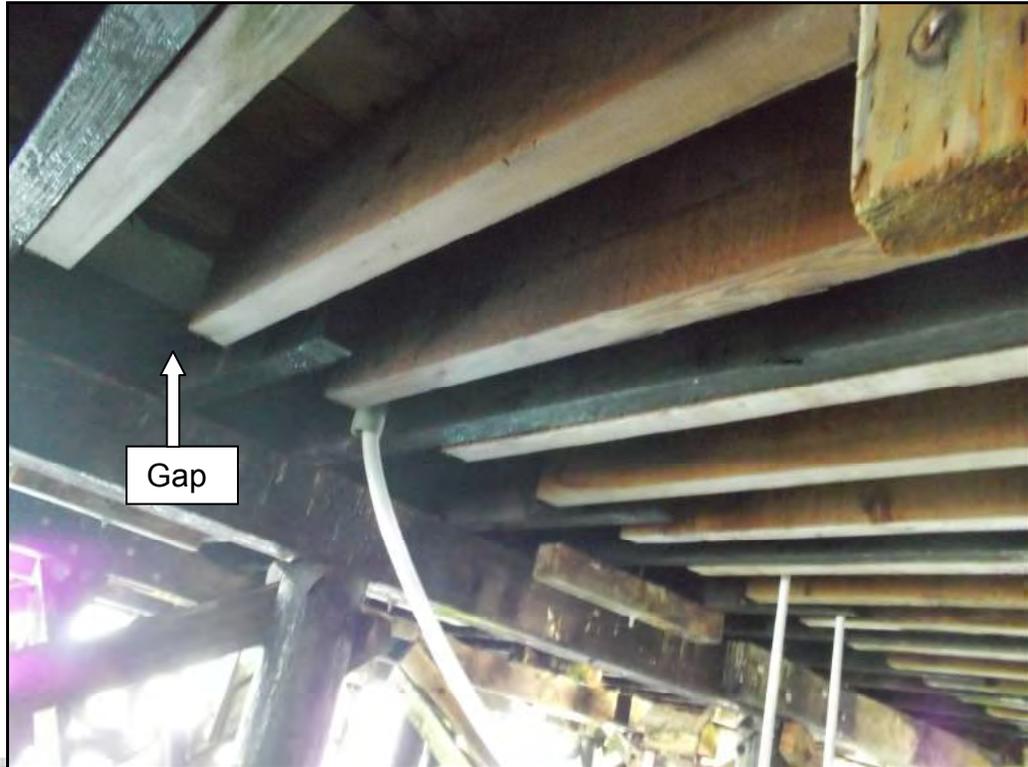
Figure 2 Floor Joists Under MSC Building, East End

The infill joists did not bear on the pile caps at the East and West ends. As shown in Figure 2 below, the joists running from grid 36 toward 37 cantilever over the pile cap only, as they do not run over the pile cap from grid 36 to 35. The distribution of treated versus infill joists can also be seen in Figure 2.

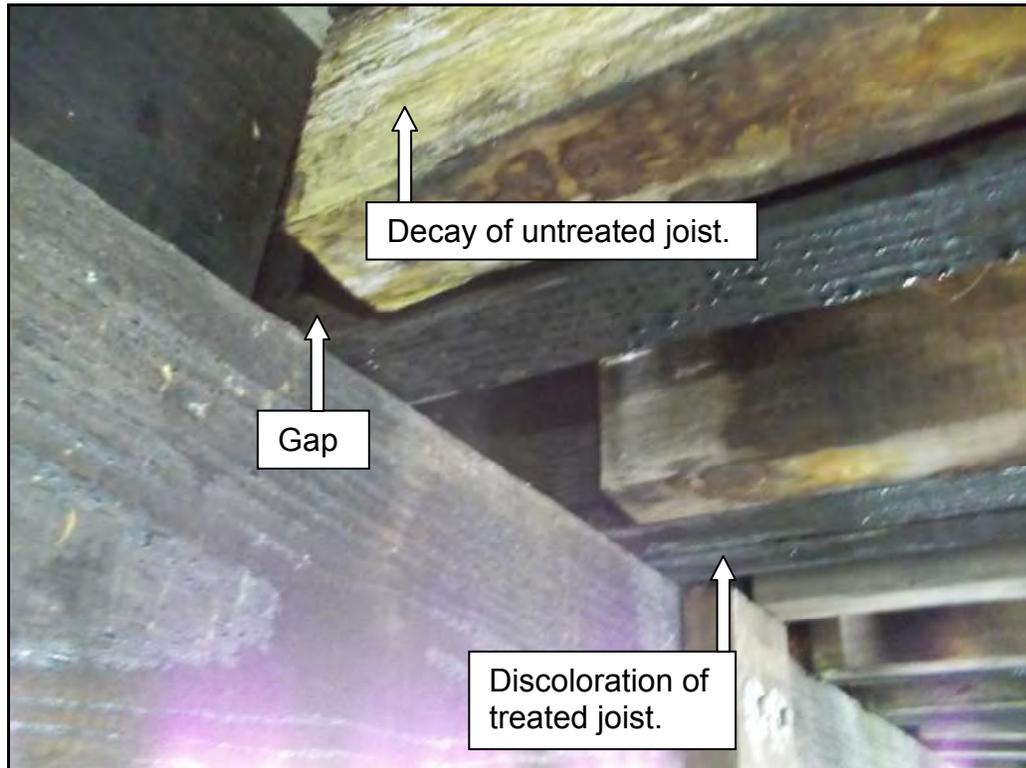
Figure 3 Decay of Untreated Joist, West End

The West ends of the infill joists generally extended past the building wall face. As such, the deterioration at the ends of the joists extended further into the members than the East end. Discoloration and soft wood were generally evident 8 to 12 inches from the end of the joists. Figure 3 shows a typical example of joist end deterioration.

Lastly, it was noted that the pile caps and floor joists under the building were not preservativesly treated. Untreated members in a marine environment generally have a faster deterioration rate than treated members, and are more susceptible to decay even if they are not directly immersed in salt water. Therefore, in addition to removing the decayed portions of the members and adding pile caps to alleviate the cantilevered ends, we recommend preparing and painting the remaining untreated members. In addition to painting, we recommend allocation of budget to fully replace approximately 10% of the members as may be deemed necessary upon closer examination during construction.

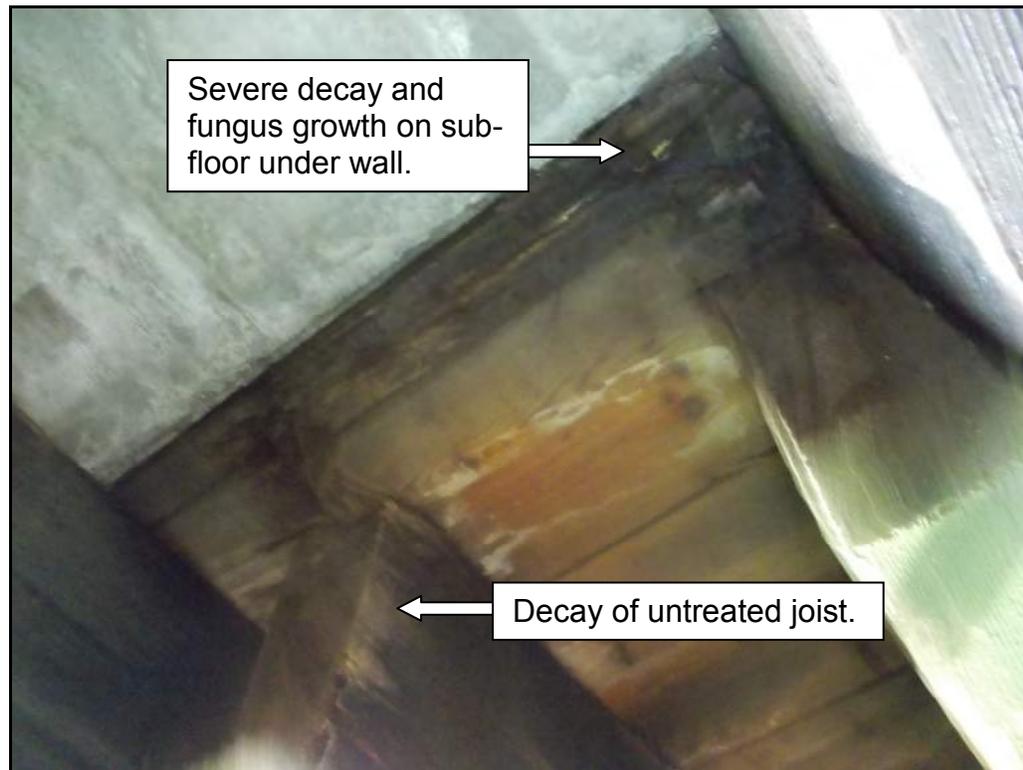
Figure 4 Floor Joists Under MSC Building, West End

The East ends of the infill joists are underneath the building proper, but they are still influenced by the sheet flow from the walls due to poor drainage detailing. As such, the exposed ends of all the untreated joists observed were moderately deteriorated, as indicated by discolored wood and low resistance to awl penetrations. The deterioration generally appeared to extend only a few inches in from the ends of the joists, as shown in Figure 4 below.

As mentioned above, the building walls appeared to bear directly on the 4x sub-flooring. The wall base does not have a mechanism for sheet flow to escape past the pier framing. As such, significant water collects at the base of the wall, as evidenced by the severe deterioration of the sub-floor members at the wall base. Figure 4 shows the perimeter sub-floor framing and joists at the East side of the building from the underside of the decking. Please see also Figure 7 in the MSC Building section for a view from the topside of the decking.

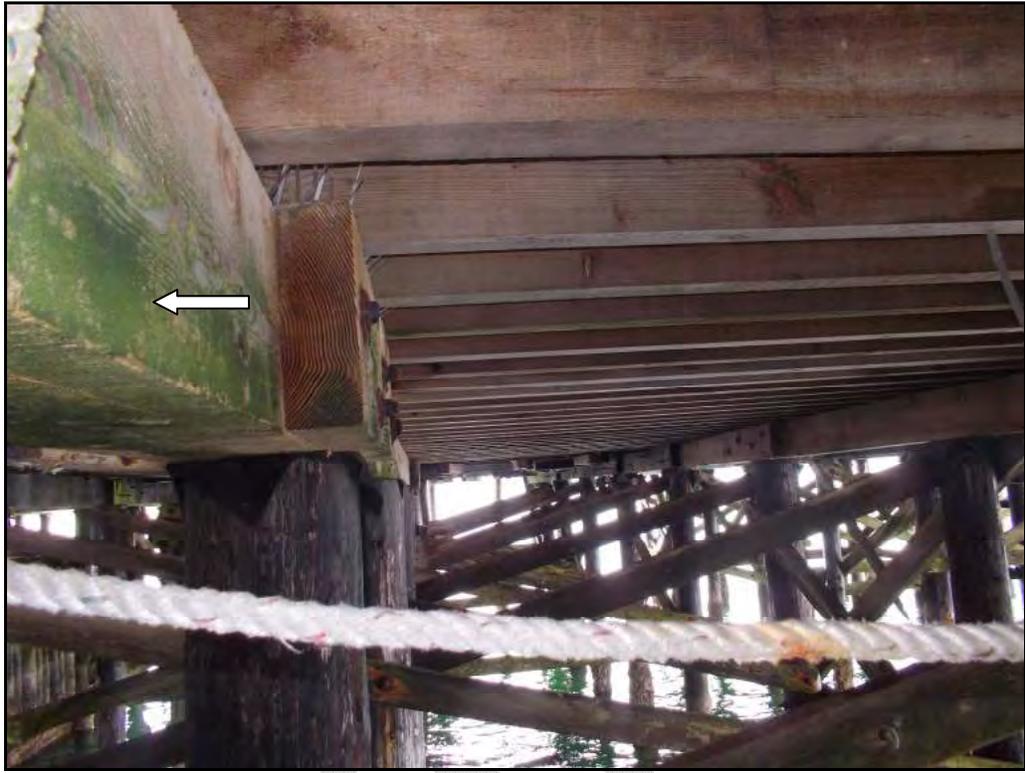
Figure 5 Biological Growth on Untreated Pile Cap

The untreated pile caps at grids 35 and 36 were in physically similar shape to the preservatively treated beams. The hammer soundings were solid, and awl penetrations were minimal. These pile caps appeared to be retaining more surface moisture, however, based on physical contact and the presence of green moss or other biological growth. Figure 5 shows a typical example. The presence of the growth does not indicate an issue in and of itself, but it could portend high enough humidity levels to cause premature deterioration of the pile caps. This is especially true when contrasted with preservatively treated pile caps.

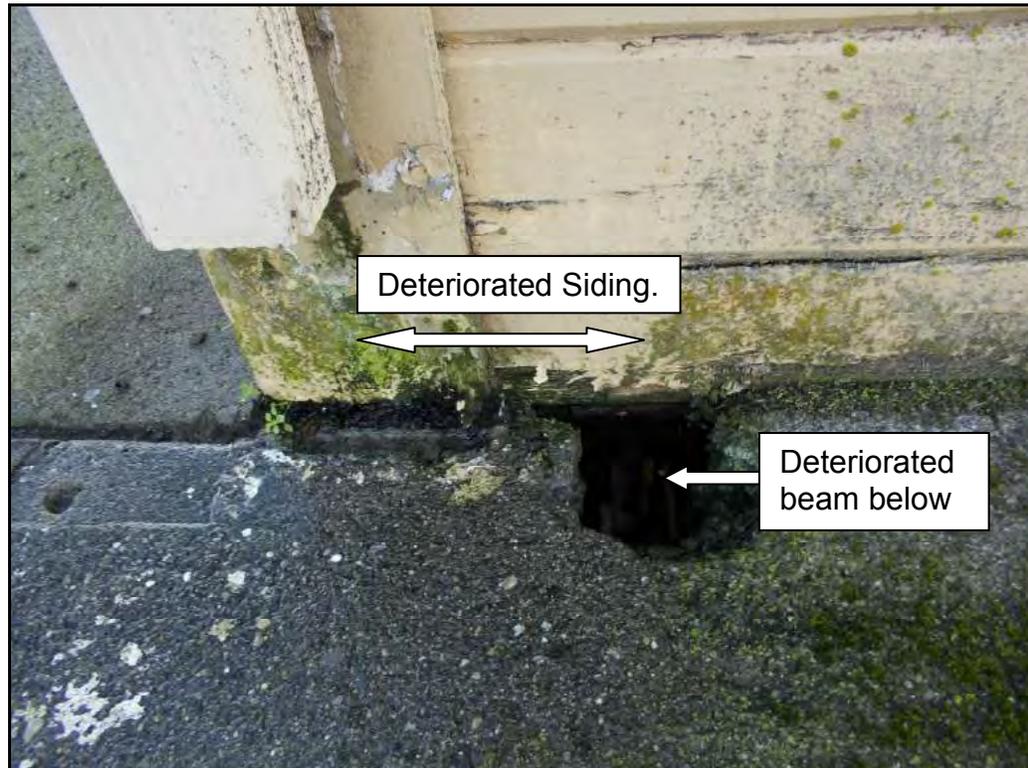
Figure 6 Downspout Outfall at Pier Deck

One area of moderate to severe deterioration of the underlying framing is at the termination of the downspouts. The downspouts terminate above the pier decking, which have rough-hewn holes that appear to be intended to provide drainage back to the bay. The area around these holes and the downspout connection show significant signs of inadequate drainage, such as moss accumulation and discoloration. The downspouts appear to create significant splash, as evidenced by the discoloration, biological growth and deterioration of the surrounding siding. Please see Figure 6 for a typical example.

The notable exception to the roof condition was the roof drainage. The roof has k-style gutters on the long side of the building, with downspouts on the four corners. As identified in section 3.4.4 above, the drainage system is inadequate and causing deterioration of the surrounding structures.

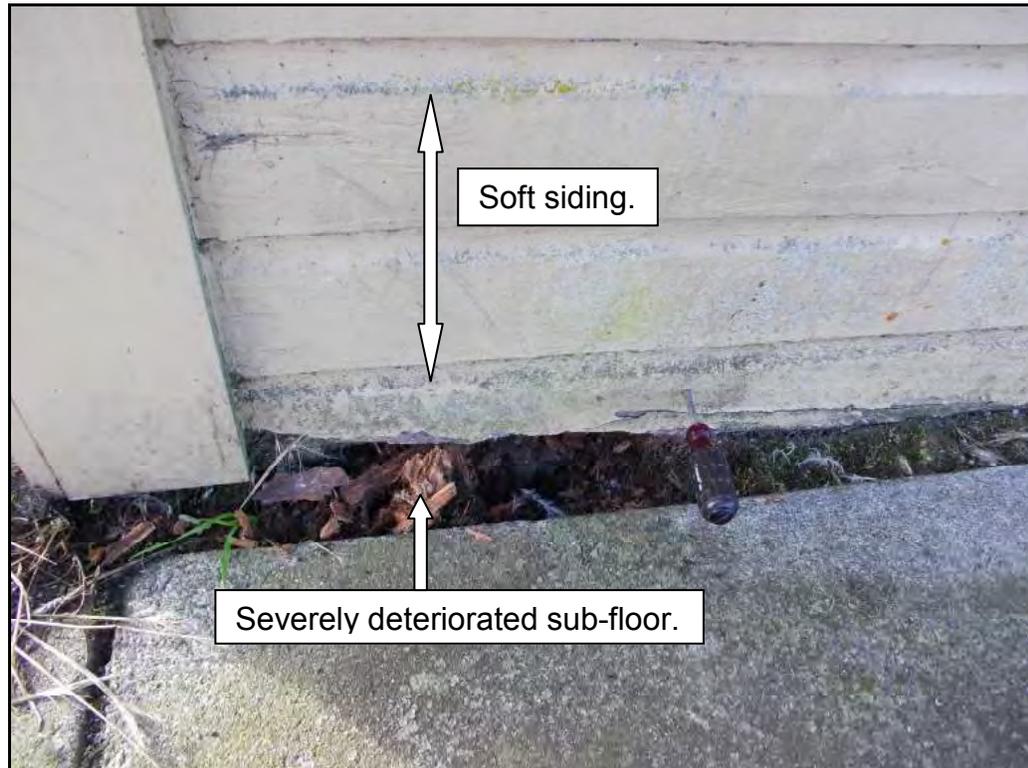
Figure 7 Building Siding at Base, North End

In conjunction with the framing at the base of the wall, the exterior sheathing on the walls had the most evidence of deterioration. With the exception of where siding had been recently replaced, all four sides of the building at the base had siding that was easily penetrated with an awl and did not sound firm under hammer blows. Please see Figure 7 for a typical example. This deterioration generally extended from the bottom course up the wall between 12 and 18 inches.

In addition to the major structural issues above, the field investigation revealed several areas of “soft” siding that should be remedied. The deteriorated siding was found around the base of the building on all four sides (except for a section that appeared to have been replaced on the SE of the building). Soft and

noticeably decaying siding was also found on the South gable end. The North gable end was not accessible during the investigation, but should be reviewed for deteriorated siding as well. It is our recommendation that all of this siding be removed to a height of sound wood, and the underlying framing be examined for signs of decay. We also recommend that the attic ventilation be reviewed, as it appears that inadequate ventilation is one of the causes of the siding deterioration of the gable end siding.

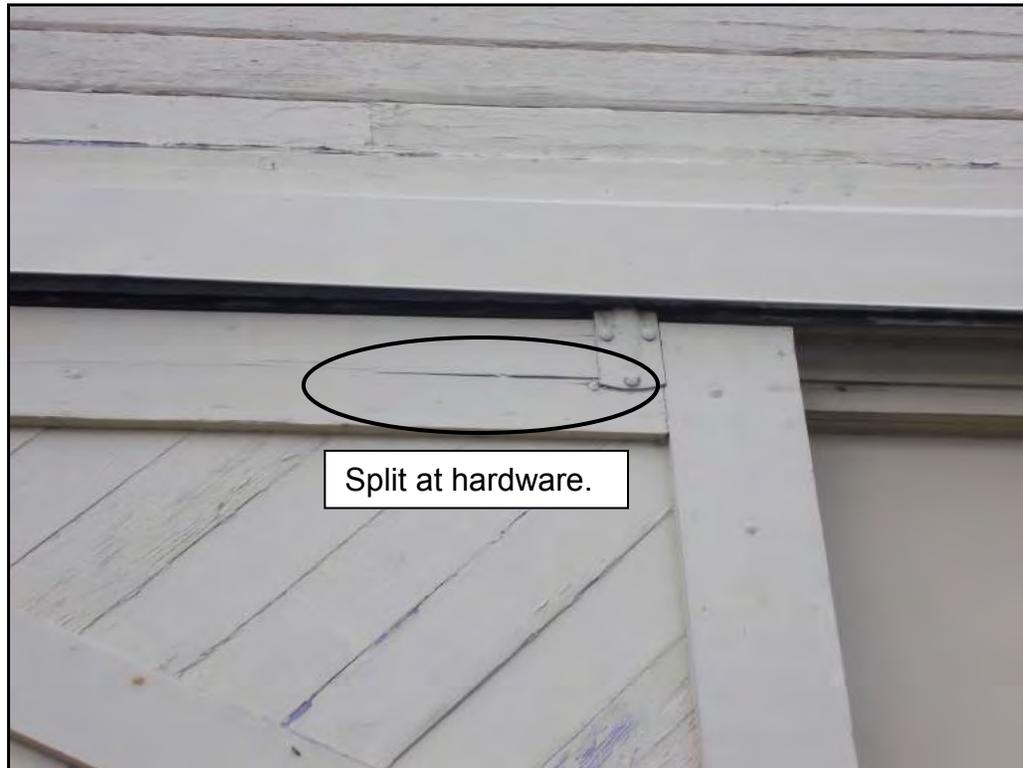
Figure 8 South End Rolling Door at Corner Hardware

The original building did not appear to have standard swing-open personnel doors, but rolling barn style doors. The barn doors currently on the structure are likely original, with the South and West doors still functional. The North door appears to have been altered to become fixed, now functionally siding rather than a door. The condition of the exterior barn doors varied, but they were generally sound with only slight softness near the bases where wood end grain was exposed. The South door was the only one that showed structural distress, with wood spitting at the rolling door hardware as evidenced in Figure 8.

The original wood windows should undergo maintenance soon to prevent more rapid deterioration and potential water infiltration. At the least, the glazing putty should be replaced, and the exterior should be prepared and painted. Additionally, the personnel doors should be prepared and painted or sealed. If the South rolling door is to remain operational, the split headrail should be repaired.

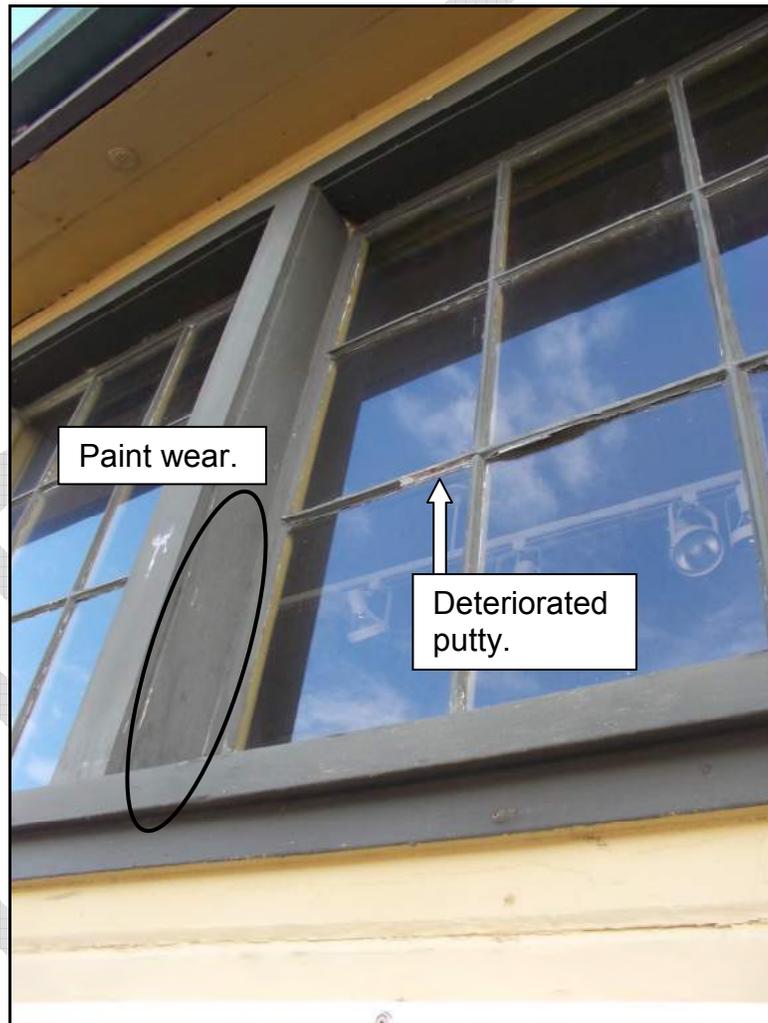
Figure 9 Wood Windows, West Side

The condition of the newer windows on the South and West sides is good. The seals on the lights appeared to be functional, and the trim was sound. The original wood window condition varied. The sills were generally sound, but the bottom of at least one mullion was soft up to approximately 2-inches above the sill. The remainder of the wood in the windows was aged, but sound, and the paint was aged but still generally adhered. The glazing putty showed signs of deterioration, separating from the glass in multiple locations and caked or spalling in others. Figure 9 shows the typical condition of the original wood windows.

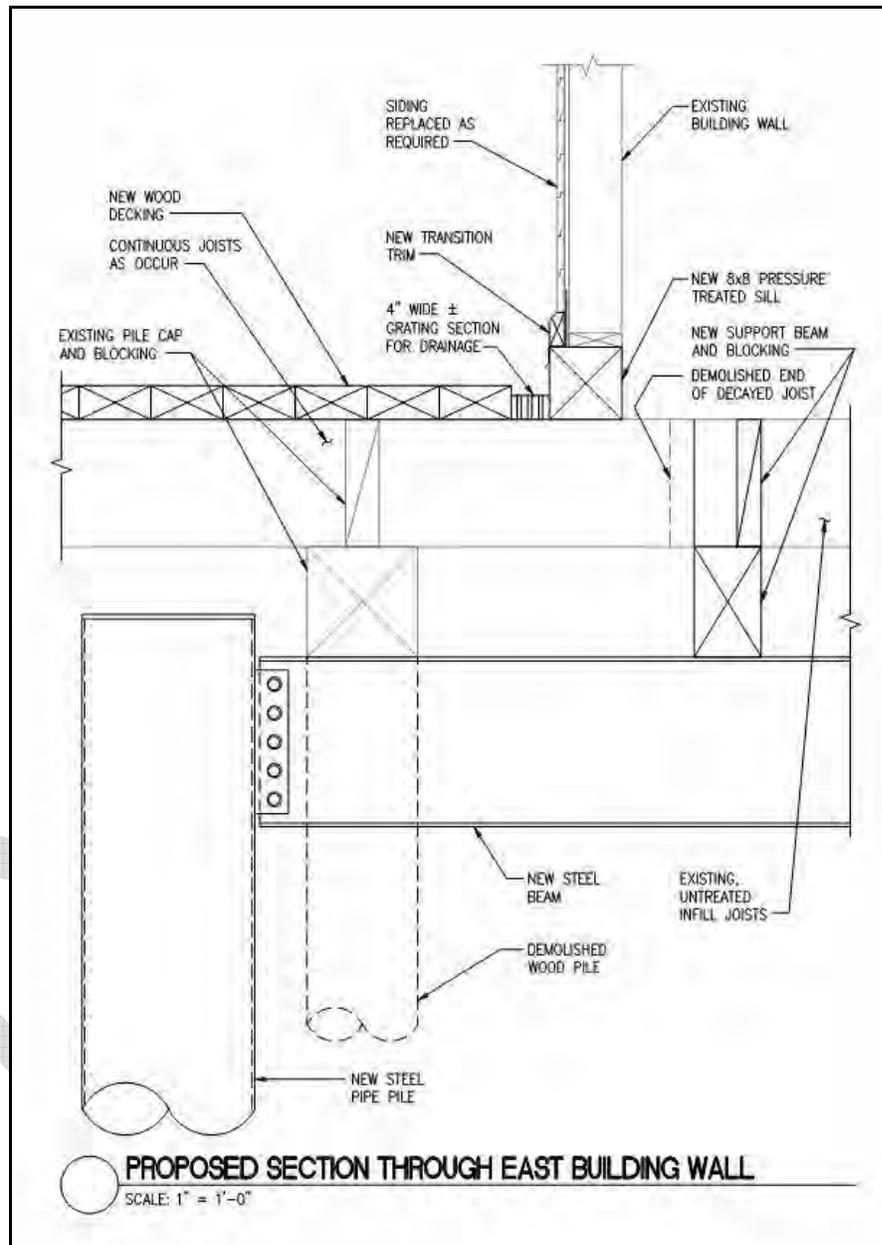
Figure 10 Schematic Sketch of Building Perimeter Framing

As identified in the Summary of Findings section, however, there are some deficiencies of the building condition and structural framing that need to be addressed. The two largest of these deficiencies are the deteriorated perimeter beams on the East and West sides of the building, and the fact that the infill floor

joists do not bear on the pile caps on the East and West ends. The following sketch, Figure 10, shows a conceptual plan for addressing these issues within the context of the schematic design presented in the following section.
