# Lake Sammamish State Park

## Tibbetts Creek Streambank Revegetation

### Existing & Proposed Conditions:

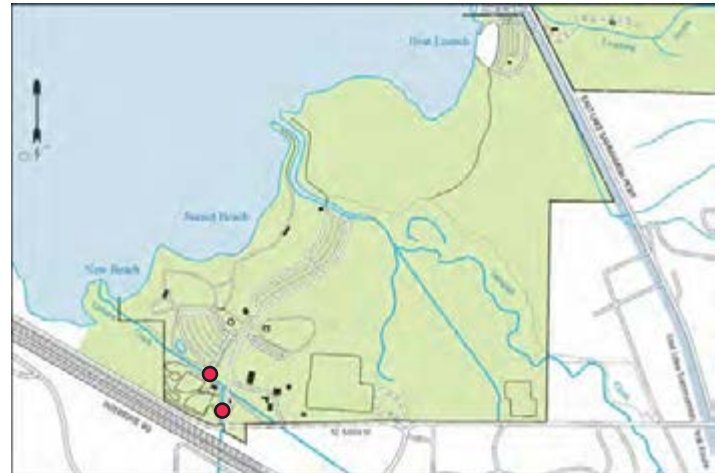
● Project location

This proposed project would expand and complete the riparian restoration along Tibbetts Creek (without further grading) to include the right stream bank for those stream sections included in the previous WSDOT project. Elements of this proposed project include Himalayan blackberry removal, with ongoing monitoring and the removal of regrowth, and the removal of unnatural debris, especially remnants of an old silt fabric fence. Once the streambank has been so-prepared, native vegetation will also be planted along the

streambank on the opposing side from the completed WSDOT project. Ongoing monitoring and maintenance will ensure the survival and growth of the planted vegetation without undue invasion by non-native species.

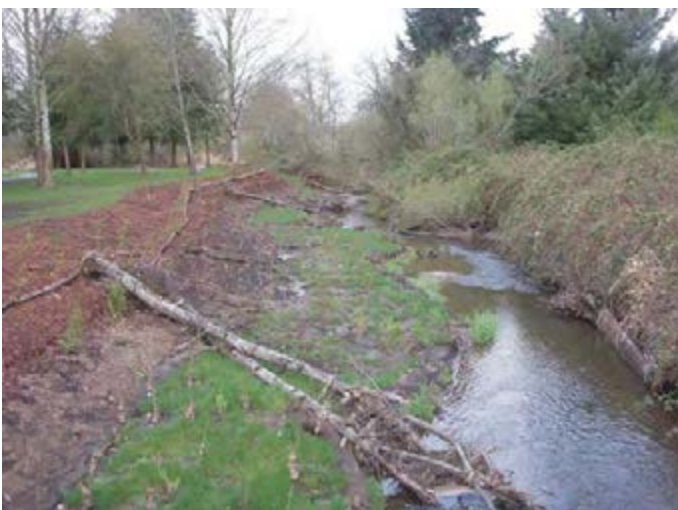
Himalayan Blackberry along existing streambank

A previous stream restoration project along Tibbetts Creek was implemented by the Washington State Department of Transportation (WSDOT) along the park entrance road and extending westward from where the creek turns away from the road. The project provided floodplain widening along the left bank (facing downstream), in-stream log structure placement, streambed gravel placement, non-native vegetation removal, and revegetation with native plant species. However, little or no work was done along the right streambank, which is still lined with dense thickets of Himalayan blackberries and some other non-native vegetation types.

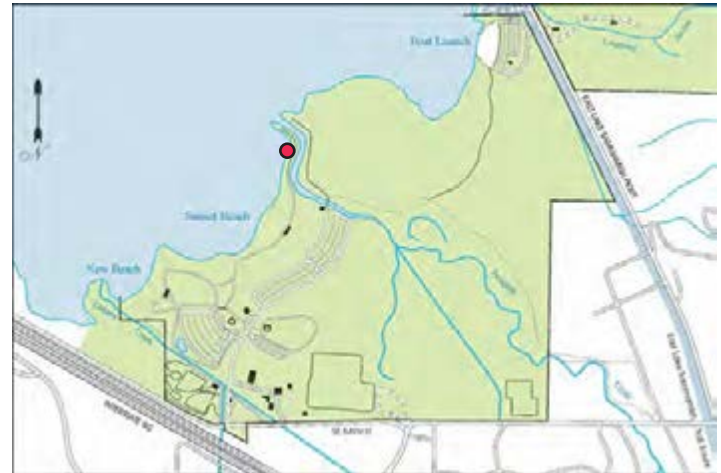
● Project location

Habitat values could be improved in this area by increasing plant species diversity and structural complexity for wildlife food and cover. Increased cover by trees, shrubs, and wetland vegetation could be planned in patches to improve edges and habitat values, while maintaining views and access to the lake. Willow cuttings in particular could be installed in dense clusters to increase and mimic some of the existing condition at the mouth of Issaquah Creek. Ivy should be removed from the cottonwoods. Habitat features such as fallen logs and buffer plantings should also be installed where possible. This project could be combined with Projects A5 and A6, which address improvements to the Issaquah Creek riparian habitat in the same general area.

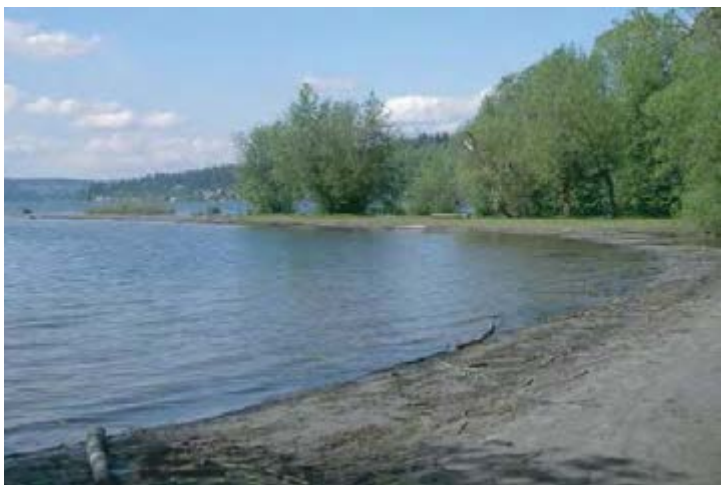
Lakeshore near the mouth of Issaquah Creek

The lakeshore extending from the north side of Sunset Beach to the mouth of Issaquah Creek is a mosaic of wetland and upland conditions. This predominantly sandy area has scattered willows, red-osier dogwood, red alder and black cottonwood trees, some covered with English ivy. It is a high use area of the park, popular with hikers, swimmers, dog walkers, and jet skiers.

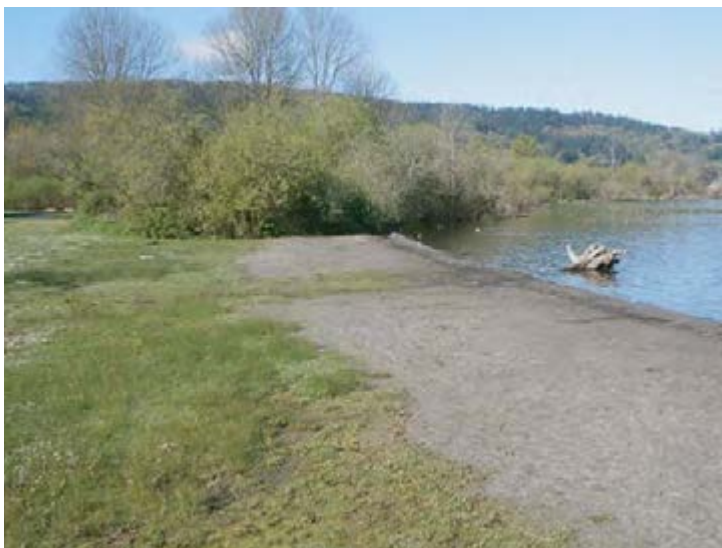
Existing beach is actually a functioning wetland

The northeast side of the lakeshore wetland is a very low quality, disturbed area dominated by lawn grasses, spike rush, and weeds. Although identified as jurisdictional wetland (part of Wetland 5A in Wetlands Inventory for the Lake Sammamish State Park Property (The Coot Company, 2005)), this wetland area is more like the beach than the more natural wetland to the west.

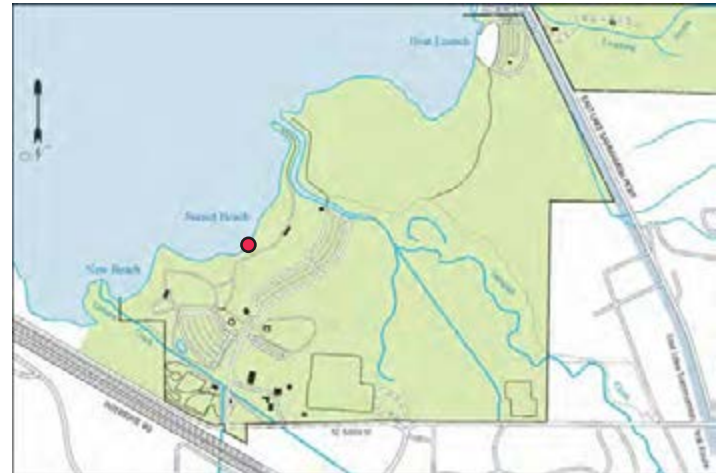
● Project location

This portion of the wetland could be restored to increase the functional area and quality of the overall lakeshore wetland. The project would also serve to raise awareness of wetland restoration needs within the park because it is in such a visible, high use area. A diversity of wetland trees, shrubs, and emergent plants could be installed here to improve wetland functions and habitat values. Wetland buffer vegetation should be planted where possible, as described in Project A7. An interpretive sign could explain the project and highlight habitat values to be improved. This project could be combined with Projects A7 and A12, which also address features of the lakeshore wetland.

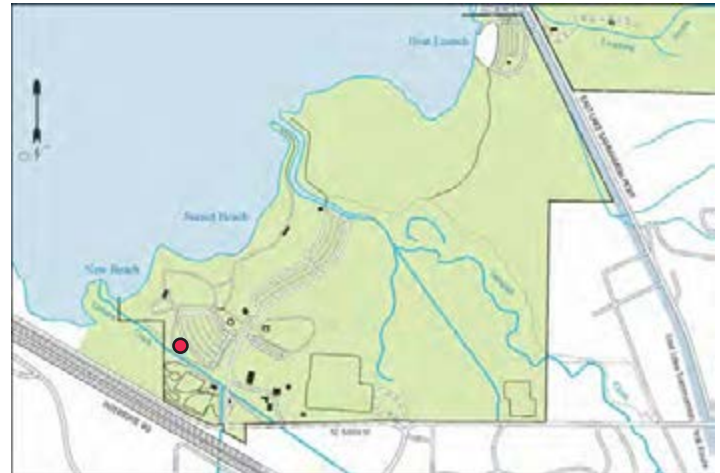
● Project location

Because this pond is in a very visible location, improvements are proposed to increase wildlife habitat values while preserving the outlook to the pond from the adjacent trail and park bench. Edge habitat could be increased and improved, and a more effective buffer could be developed. Blackberries, reed canarygrass, and other weedy species along the edges of the pond should be removed and replaced with a variety of native trees and shrubs that would increase edge habitat and food and cover values for wildlife. Low-

growing shrubs, such as rose, snowberry, and salal should be chosen and planted in clusters to preserve views. Existing trees could be limbed to enhance aesthetics and better accommodate shrub clusters. An interpretive sign explaining zoning and layering of plants in the community, edge habitat, and the value of native plants could be installed here.

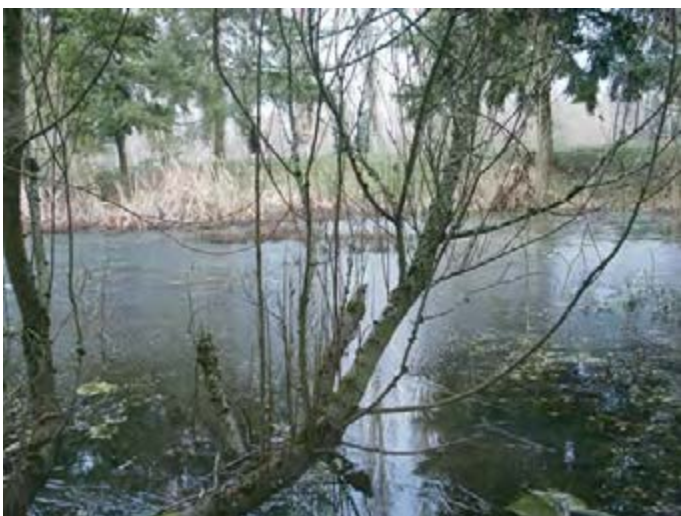
Existing pond edged by reed canarygrass

There is a relatively small pond (0.27 acres) along the southwest side of the New Beach parking lot. This detention pond is adjacent to an existing trail from the parking lot, which crosses Tibbetts Creek on a footbridge, and directs people to the baseball fields. Presently, there is a fairly diverse plant community associated with the pond including Douglas fir, red alder and willows, with mostly blackberries in the shrub layer. Emergent and aquatic plants include cattail, yellow iris, slough sedge, lady fern, soft rush, and water smartweed. The pond edges and surrounding buffer areas are mostly lawn grasses, reed canarygrass, creeping buttercup, and birds-foot trefoil.

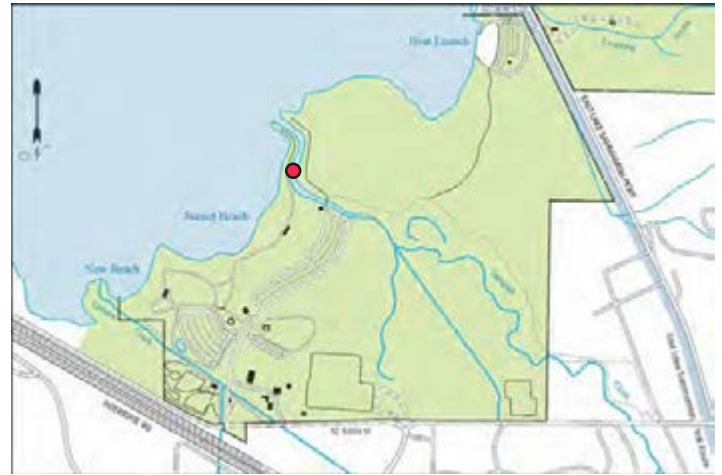
● Project location

Near the mouth of Issaquah Creek along the trail on the left (west) bank is an open area bordering the creek. The site includes two live conifers and a snag along the bank, which is otherwise vegetated almost exclusively with reed canarygrass. The area is approximately 105 feet long by 40 feet wide, extending downstream from an existing fence. Proposed project improvements for this area would entail revegetation with native plant species, possibly retaining a viewpoint.

It is proposed as part of this potential project that these blackberries be systematically and thoroughly hand-removed and that the area be maintained in a virtually blackberry-free condition.

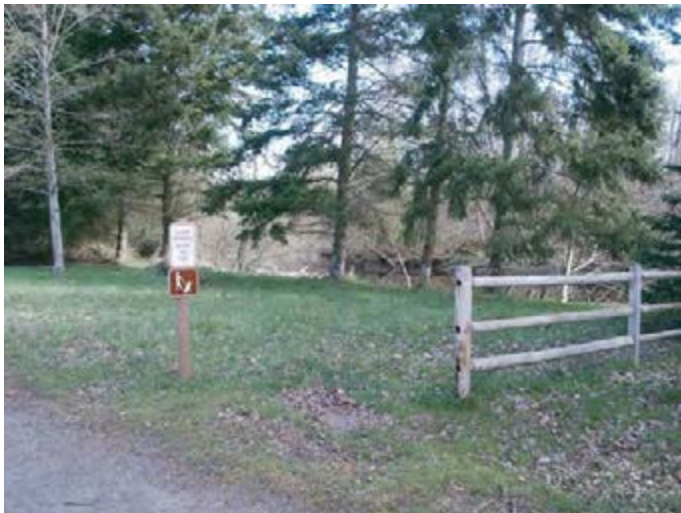
Issaquah Creek streambank near Sunset Beach

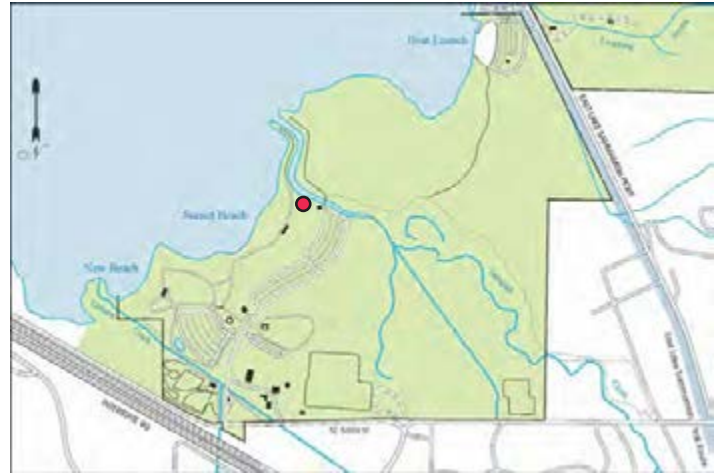
● Project location

Removing and reconfiguring parking lot pavement and implementing a native planting plan would create a wider creek buffer. A significantly scaled back version would involve planting the existing 20-to-25-foot-wide grassy strip adjoining the existing pavement to provide a total vegetated buffer width of 40 to 50 feet. For the left bank buffer areas extending downstream from the footbridge, the project would involve relocating the trail along a somewhat meandering alignment through trees closer to the enclosed picnic area, but farther from the creek, and providing native understory revegetation between the relocated trail and the creek. Building a fence closer to the new trail alignment is a possibility, but not a neces-

sity; neither would it be necessary to remove the existing rail fence along the top-of-streambank. Native revegetation and trail relocation extending farther downstream through the adjacent grassy area along the streambank would serve to further increase the length of stream for which a widened functional stream buffer would be provided.

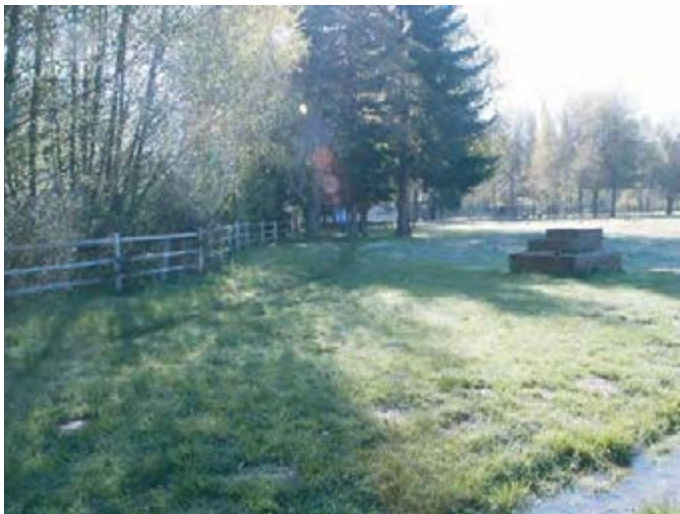
Issaquah Creek streambank near footbridge

Upstream of the Issaquah Creek footbridge along the left (southwest) streambank, the existing parking lot leaves little space available to provide a well-functioning buffer for the creek. Downstream of the footbridge along the same bank, beginning at the stream, is a rail fence in need of repair, a trail through an open conifer forest, and an enclosed volleyball/picnic area. An open, grassy area occupies the would-be stream buffer areas extending farther downstream to the west.

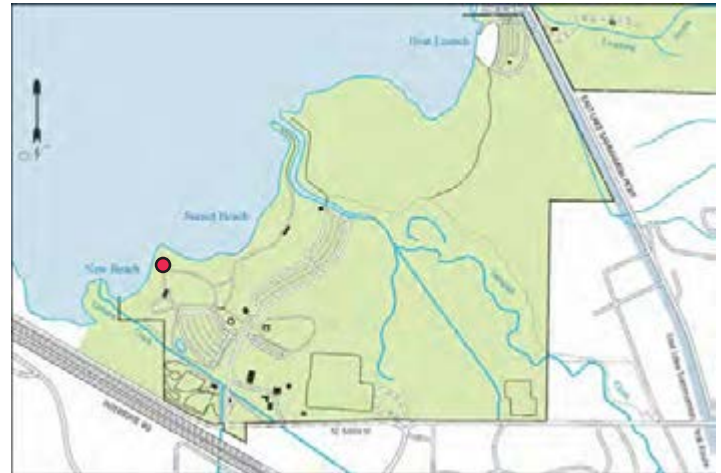
● Project location

Wetland buffer plantings should be installed to create additional edge habitat and a more diverse plant community. Conifers, in particular, are lacking in this area, and the addition of firs and cedars would enhance the habitat diversity. There is space for an approximately 25-foot wide buffer area on a hummock between the beach and the wetland. This area could be extended around the wetland as far as possible to the east. Interpretive signage along the trail could be installed to explain the improvements and provide information about habitat features. This project could be combined with Projects A3 and A12, which also address features of the lakeshore wetland.

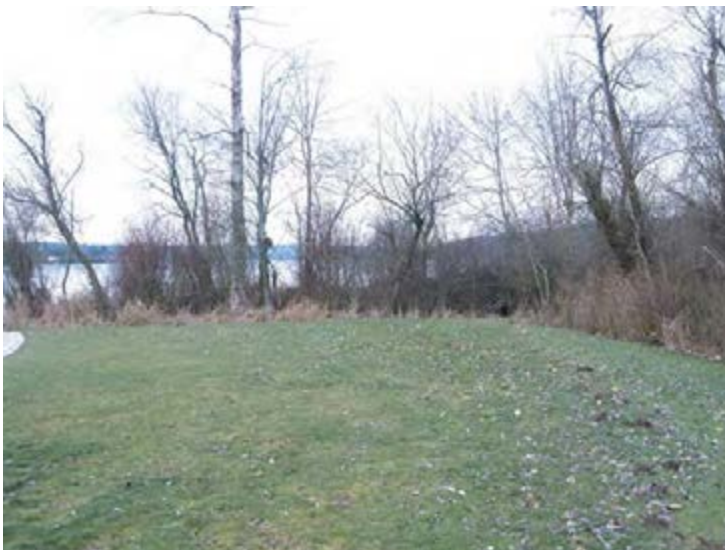
Existing wetland buffer

There is essentially no wetland buffer adjacent to the lakeshore wetland between New Beach and Sunset Beach. The west side is presently mowed grass and sand. This wetland was identified as Wetland 5A in Wetlands Inventory for the Lake Sammamish State Park Property (The Coot Company, 2005).

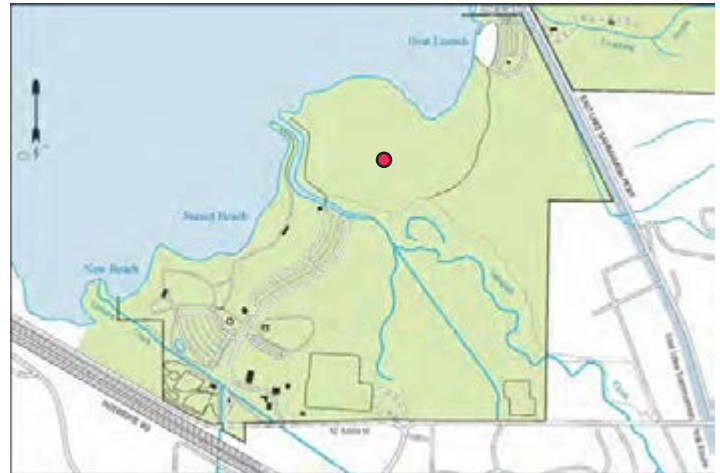
● Project location

This area provides an opportunity to create a variety of upland plant communities which would provide a unique assemblage of food and cover opportunities for wildlife diversity. Upland forest and shrub patches or islands could be planted in a scattered fashion to maximize edges while maintaining the open meadow character of the area. The view of the great blue heron rookery should be preserved. An interpretive sign along

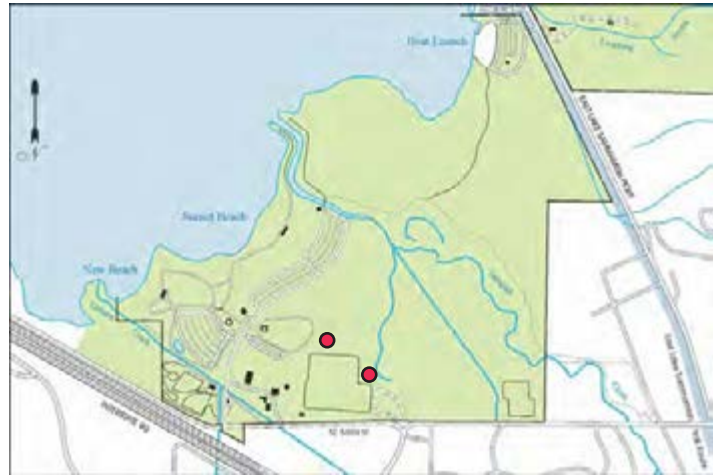
● Project location

Much of the main soccer field complex (westernmost fields) is jurisdictional wetland. The edges adjacent to the mowed and maintained fields are mostly reed canarygrass with some blackberry thickets and other weedy species. There are parking lots on both the west and east sides of the fields. This area was identified as Wetland 6A in Wetlands Inventory for the Lake Sammamish State Park Property (The Coot Company, 2005).

Orienting visitors to their location in a much larger park setting and including interpretive elements would enhance recreational opportunity for families and children before, during and after soccer games. This project also could be combined with Project A17 for enhanced educational and passive recreational elements.

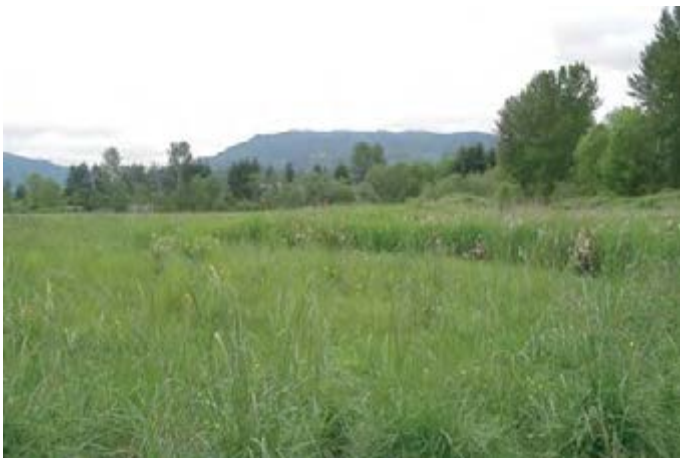
Existing open field lacks habitat values

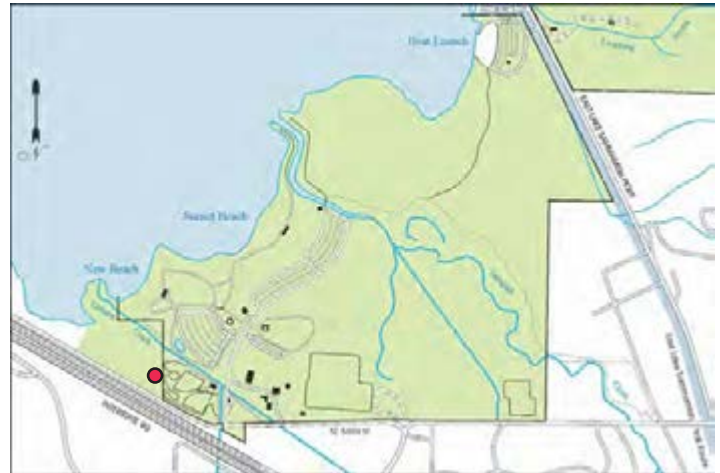
● Project location

This trail could be improved for greater use by park visitors by providing a destination and a reason for meandering. The fairly aimless form of the existing trail invites non-use. Trail destinations could include an area along a restored portion of Tibbetts Creek, and a connection to a larger trail system in and around the restored Greenwood property as presented in Project C4. Additional plantings along the trail could increase aesthetics and provide enhanced food and cover values for wildlife.

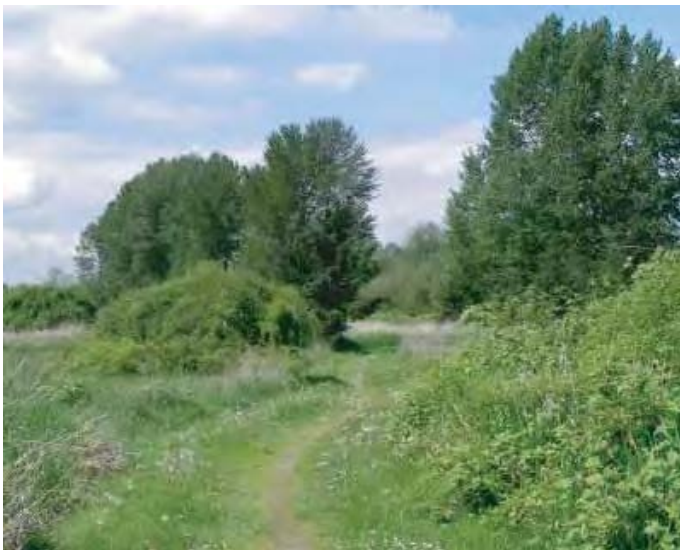
Existing trail near baseball field

Just west of the baseball fields is a trail that meanders through the trees and is used primarily by children riding bikes while their siblings play baseball.

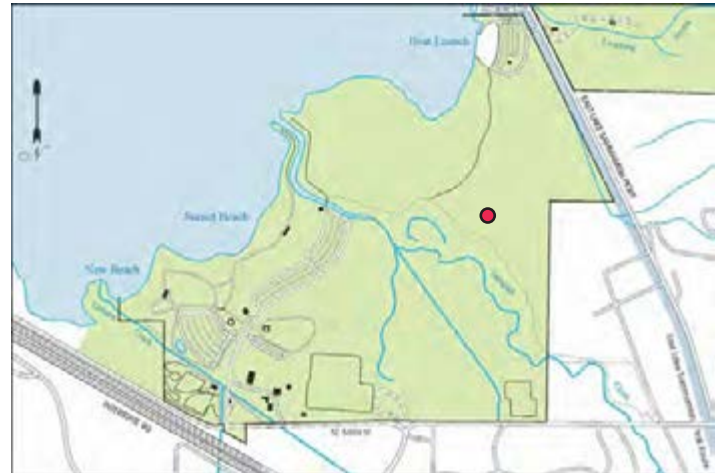
● Project location

This area provides an opportunity to create a variety of upland and wetland plant communities, which could be designed to provide a unique

assemblage of food and cover opportunities for wildlife diversity. Forest and shrub patches or islands could be planted in a scattered manner to maximize edges while maintaining the open meadow character of the area. This project could be combined with Project B9, which proposes an interpretive area and trail highlighting the oxbow and associated stream processes.

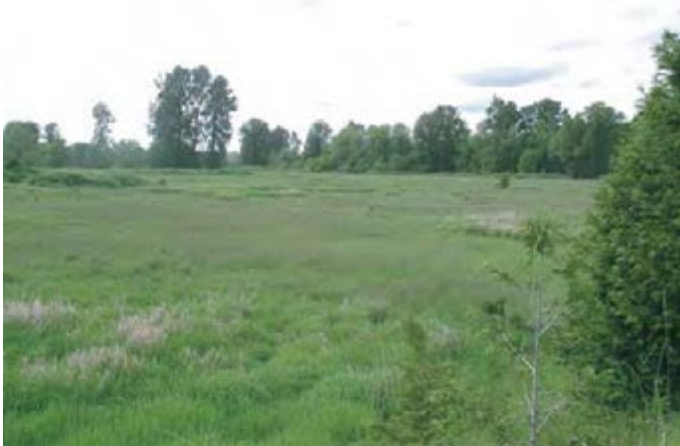
Existing open field lacks habitat values

The field northeast of the old oxbow on the north side of Issaquah Creek is approximately 20 acres in size. This area is a combination of wetland and upland features, bordered by wetland to the north and east and by Issaquah Creek to the southwest. An existing trail is located in the southern portion of this field. Much of the area is dominated by a variety of grass species, horsetail, buttercup, and vetch, bordered by blackberry thickets and trees beyond. Patches of soft rush, slough sedge, and reed canarygrass are present in the wetter portions to the east. This area was not specifically delineated in the Wetlands Inventory for the Lake Sammamish State Park Property (The Coot Company, 2005), but was generally described and identified in the discussion of Issaquah Creek Uplands. The report characterizes this area as a “combination of slightly higher ground built up from flood overflow deposition plus the drainage effects from the creek channel ‘zone of influence’ which has created mostly linear ‘islands’ of upland ground along both sides of the creek.”

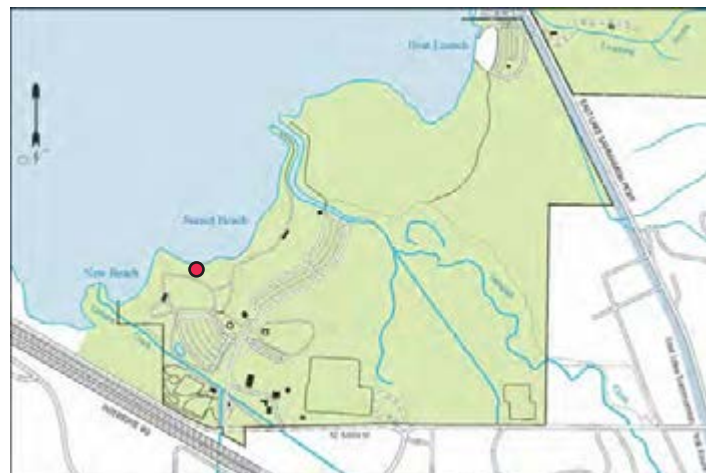
● Project location

The lakeshore vegetation fringe could be expanded into reed canarygrass areas by mowing and installing willow stakes in clusters. Western red cedar and Sitka spruce trees could be inplanted among the existing trees and shrubs to add a coniferous component to this habitat. Additional shrub plantings such as gooseberry, twin-berry, salmonberry, and rose could be planted in clusters to increase edge habitat and wildlife food and cover values. Logs and woody debris could be installed to increase the structural diversity of the habitat. Native emergents such as hardstem bulrush could be installed along the lakeshore. Wetland buffer vegetation should be planted where possible, as described in Project A7. This

project could be combined with Projects A3 and A7, which also address features of the lakeshore wetland.

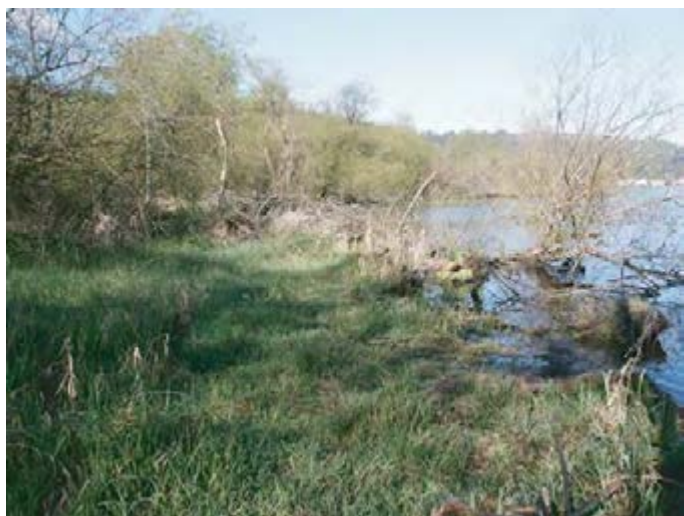
Lakeshore between New Beach and Sunset Beach

The lakeshore wetland between New Beach and Sunset Beach is a fairly diverse community of aquatic, emergent, scrub-shrub, and forested wetland features. However, there are portions that have become dominated by reed canarygrass and blackberries, both in the interior of the wetland and along the edges. This wetland was identified as Wetland 5A in Wetlands Inventory for the Lake Sammamish State Park Property (The Coot Company, 2005).
